1. Defect recognition on saw blade discs

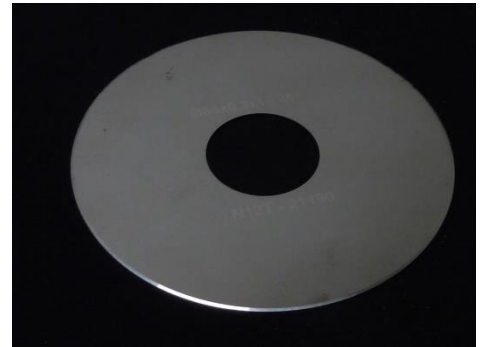
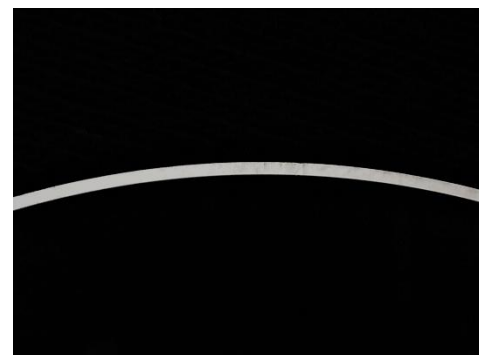
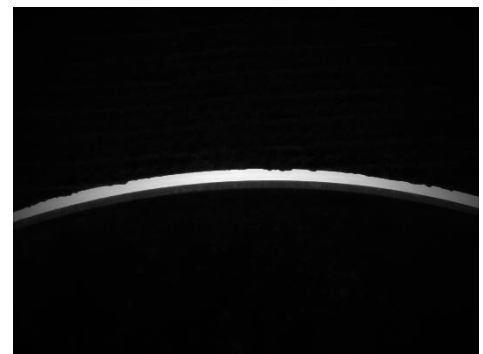
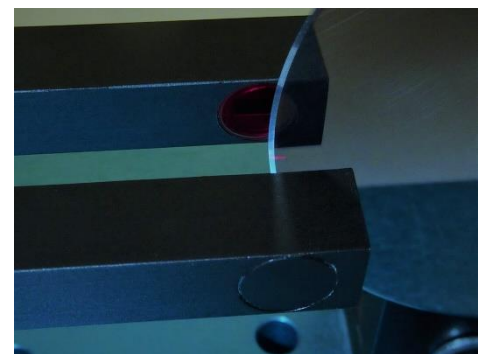
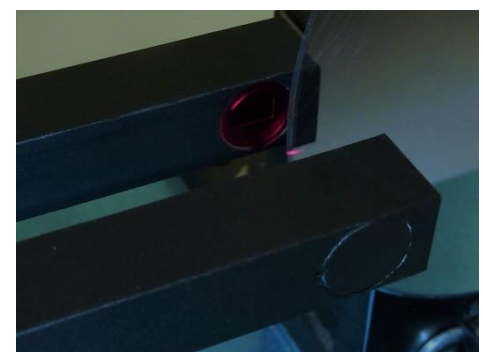
Defects on saw blade discs should be detected. For this purpose, a laser analog through beam sensor type **A-LAS-F08-3x0.3-10/50** in connection with a control electronics type **A-LAS-CON1** is used. At this, the saw blade is positioned approximately in the middle of the fork light barrier in a way to cover around half of the laser beam. The defects in the blade can be proper detected, as shown in the screen shots.
